Bioengineering Bulletin

Department of Medical Engineering and Physics Royal Perth Hospital March 2010

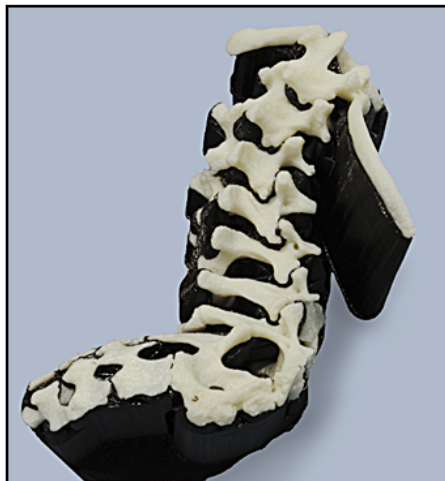
Spine model with support material

The capacity of the printer is such that we can produce models as large as a full pelvis and as long as a femur with a resolution of 0.25mm. Printing times range from 8 to 36 hours, depending on the size of the model. The model is initially produced with support material which is subsequently dissolved away in a mildly basic solution.

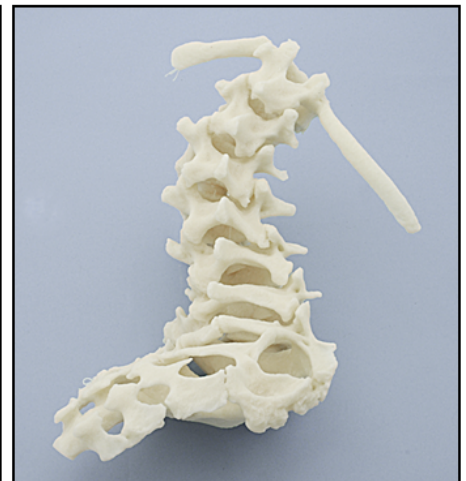
Spine model

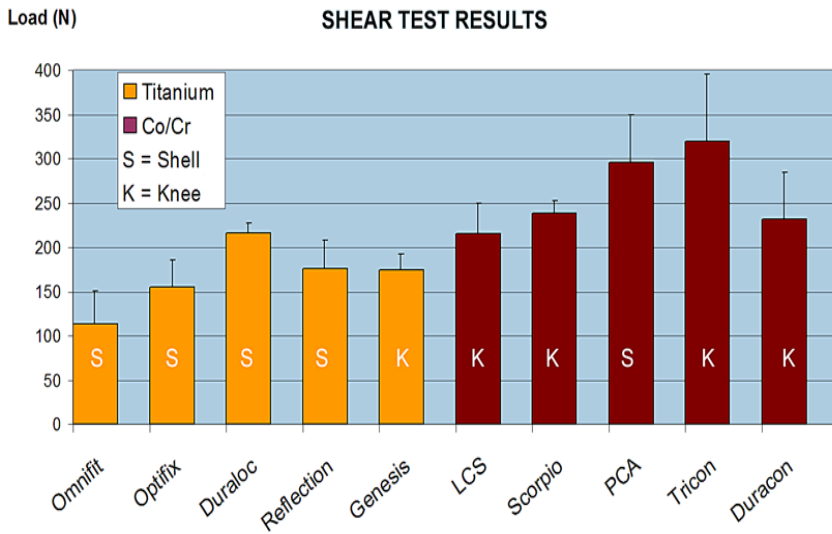
Acetabular liner with embedded beads

Shell with missing beads

Bead shedding is not an uncommon complication with porous coated arthroplasties. Bead loss varies between designs and components. In our implant retrieval collection, 42% of Omnifit shells (Dual Geometry), 36% of Optifix shells and 27% of LCS knees demonstrated bead shedding.
